FATIGUE BEHAVIOR
OF GRAPHITE COMPOSITES

Final Report
(9 Feb. 1971 to 8 Feb. 1972)
February, 1972

Prepared Under Contract No. N00019-71-C-0212

IIT RESEARCH INSTITUTE

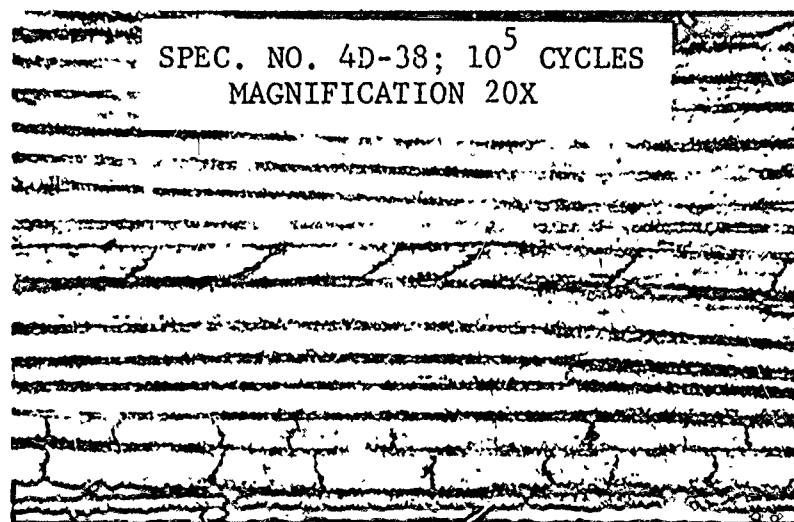
FIG. A-12 CROSS SECTIONAL PHOTOMICROGRAPHS OF MODMOR II/NARMCO 5206 PREPREG 16 PLY - 45°/135° (WITH SCRIM CLOTH) COMPOSITE CANTILEVER BEAM SPECIMENS SUBJECTED TO VARIOUS FATIGUE STRESS CYCLES AT $R = 0.1$ (MAX. LOAD/CYCLE = 174 LBS), ROOM TEMPERATURE, DRY.

<u>Specimen No.</u>	<u>No. of Cycles *</u>	<u>Figure No.</u>
4D-1	10,000	A-10
4D-5	10,000	A-10
4D-6	10,000	A-10
4D-24	50,000	A-11
4D-33	50,000	A-11
4D-65	50,000	A-11
4D-8	100,000	A-12
4D-34	100,000	A-12
4D-38	100,000	A-12
4D-13	500,000	A-13
4D-55	500,000	A-13
4D-60	500,000	A-13

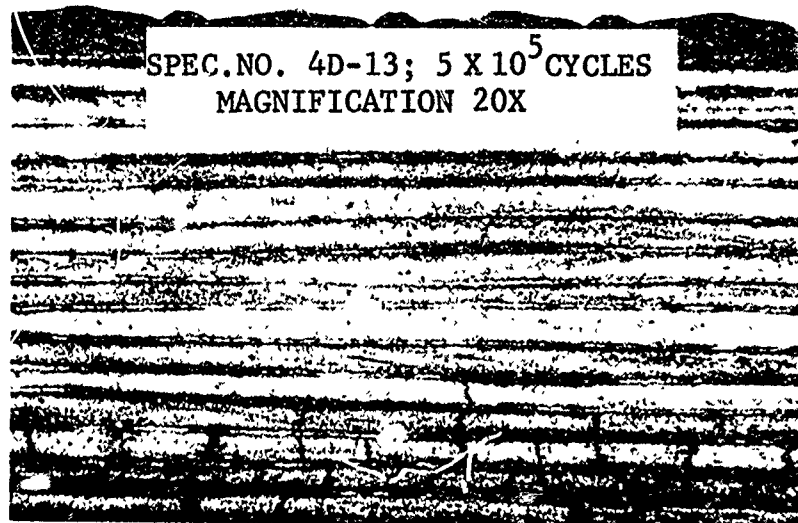
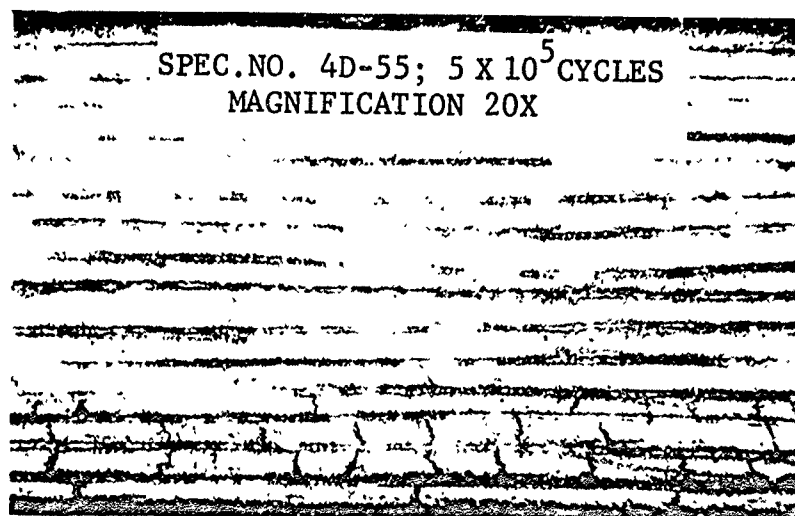
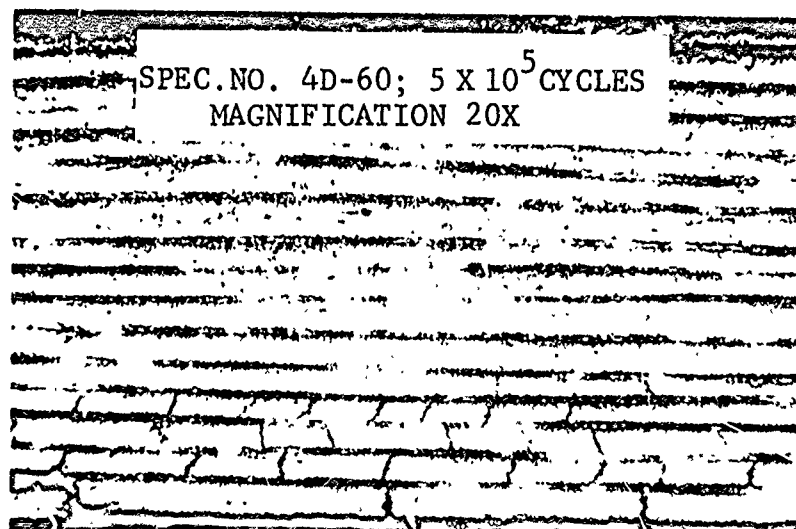
FIG. A-13 CROSS SECTIONAL PHOTOMICROGRAPHS OF MODMOR II/NARMCO 5206 PREPREG 16 PLY - $45^\circ/135^\circ$ (WITH SCRIM CLOTH) COMPOSITE CANTILEVER BEAM SPECIMENS SUBJECTED TO VARIOUS FATIGUE STRESS CYCLES AT $R = 0.1$ (MAX. LOAD/CYCLE = 174 LBS), ROOM TEMPERATURE, DRY.

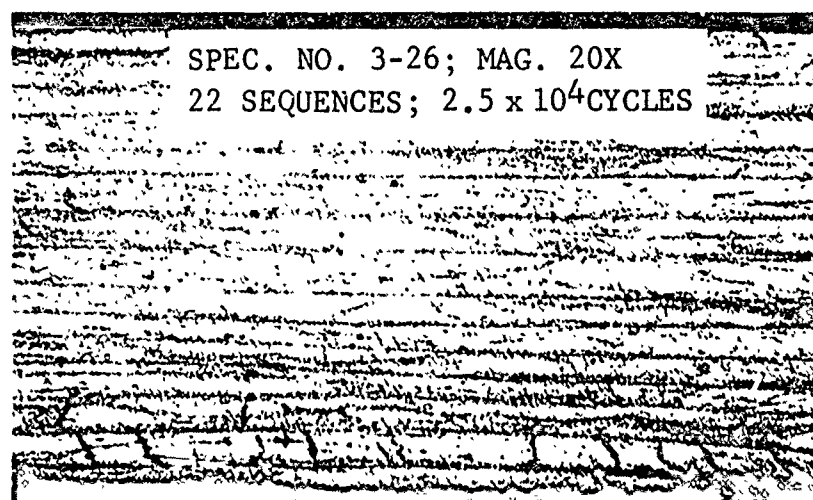
FIG. B-1 CROSS SECTIONAL PHOTOMICROGRAPHS OF MODMOR II/NARMCO 5206 PREPREG 16 PLY - 45° , 135° COMPOSITE CANTILEVER BEAM SPECIMENS SUBJECTED TO VARIOUS FATIGUE ($R = 0.1$) LOAD SEQUENCES AT ROOM TEMPERATURE

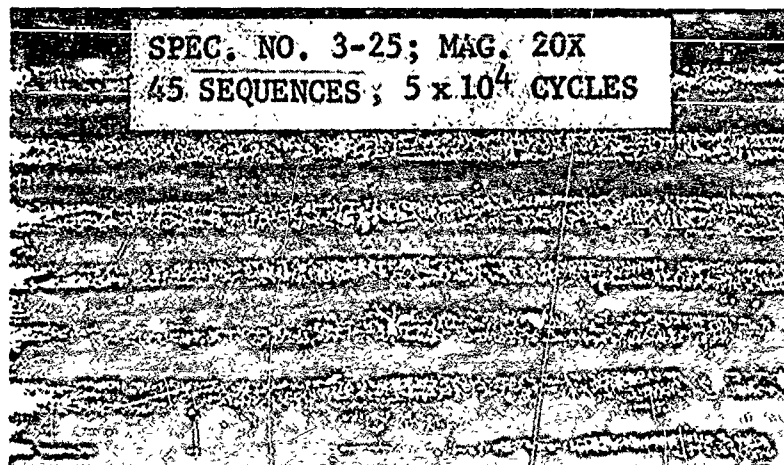
FIG. B-2 CROSS SECTIONAL PHOTOMICROGRAPHS OF MODMOR II/NARMCO 5206 PREPREG 16 PLY - 45°, 135° COMPOSITE CANTILEVER BEAM SPECIMENS SUBJECTED TO VARIOUS FATIGUE ($R = 0.1$) LOAD SEQUENCES AT ROOM TEMPERATURE

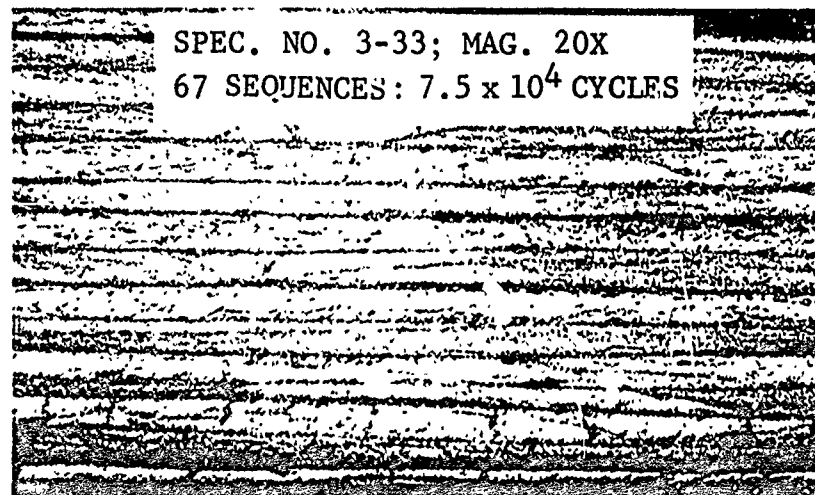
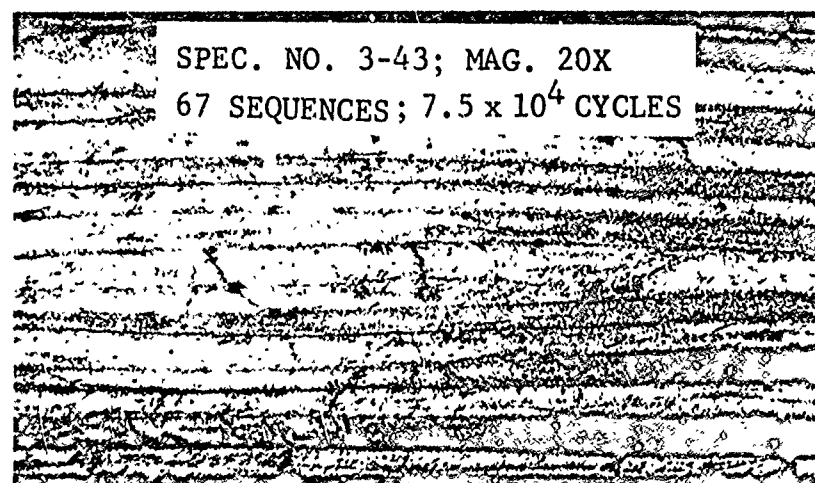
FIG. B-3 CROSS SECTIONAL PHOTOMICROGRAPHS OF MODMOR II/NARMCO 5206 PREPREG 16 PLY - 45° , 135° COMPOSITE CANTILEVER BEAM SPECIMENS SUBJECTED TO VARIOUS FATIGUE ($R = 0.1$) LOAD SEQUENCES AT ROOM TEMPERATURE

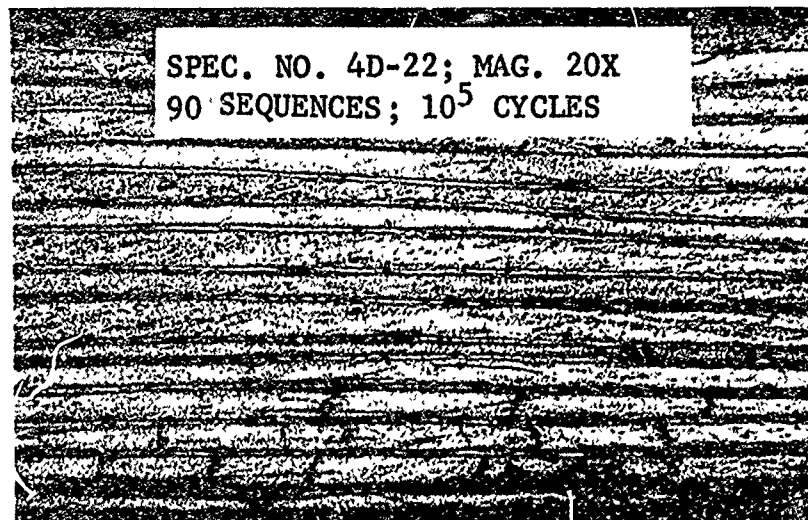
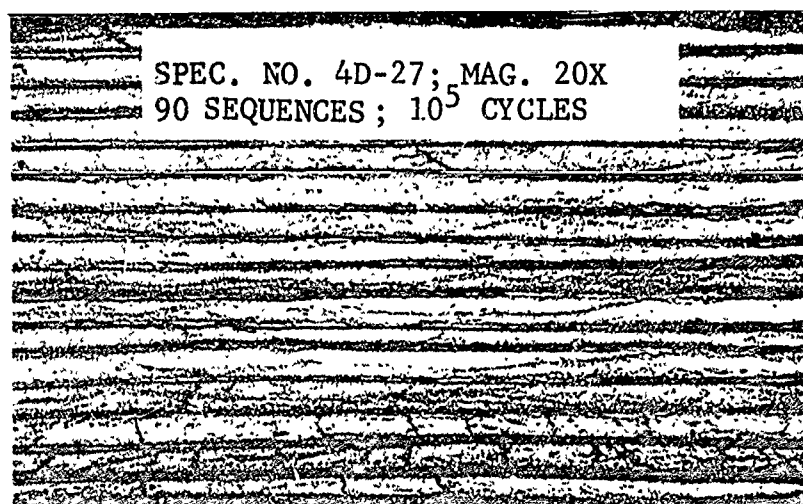
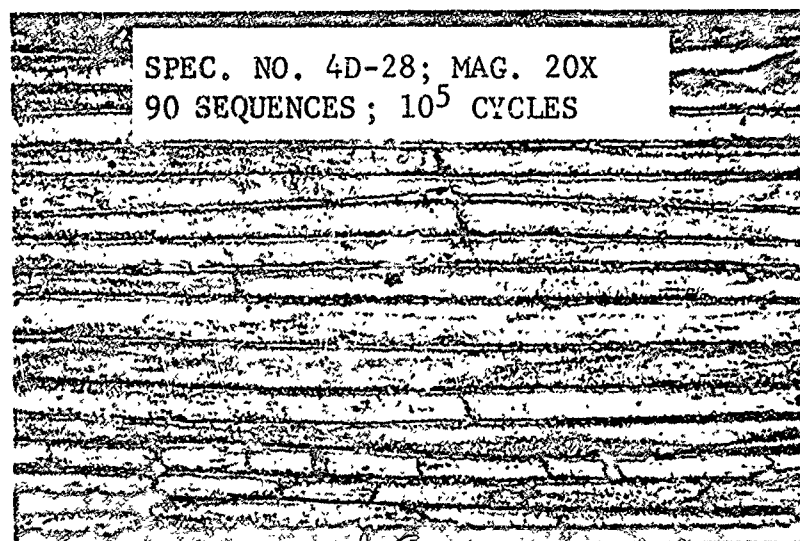
FIG. B-5 CROSS SECTIONAL PHOTOMICROGRAPHS OF MODMOR II/NARMCO 5206 PREPREG 16 PLY - 45° , 135° (WITH SCRIM CLOTH) COMPOSITE CANTILEVER BEAM SPECIMENS SUBJECTED TO VARIOUS FATIGUE ($R = 0.1$) LOAD SEQUENCES AT ROOM TEMPERATURE

Specimen No.	No. of Spectrums	No. of Cycles	Figure No.
4D-2	45	50,000	B-4
4D-11	45	50,000	B-4
4D-22	90	100,000	B-5
4D-27	90	100,000	B-5
4D-28	90	100,000	B-5
4D-35	135	150,000	B-6
4D-41	135	150,000	B-6
4D-57	135	150,000	B-6

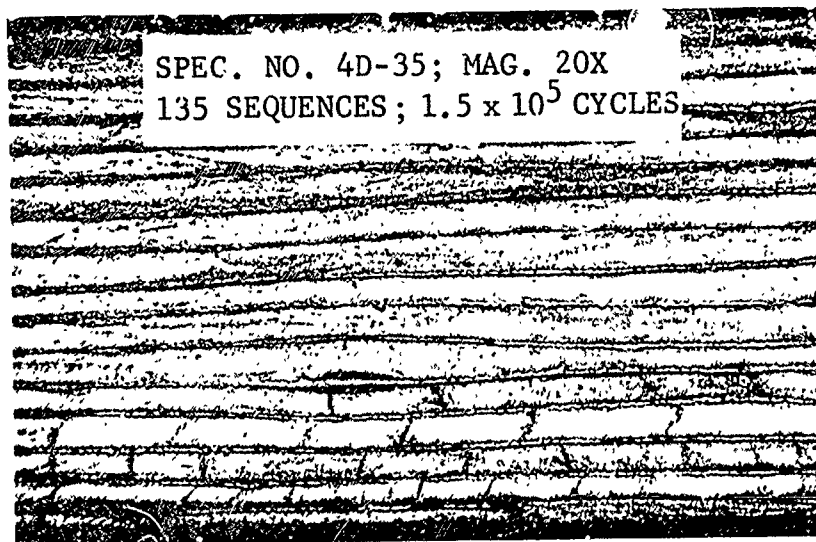
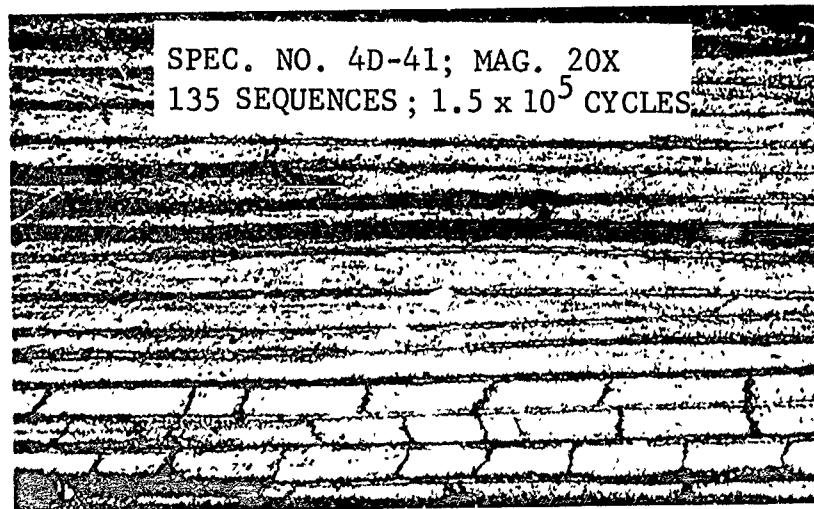
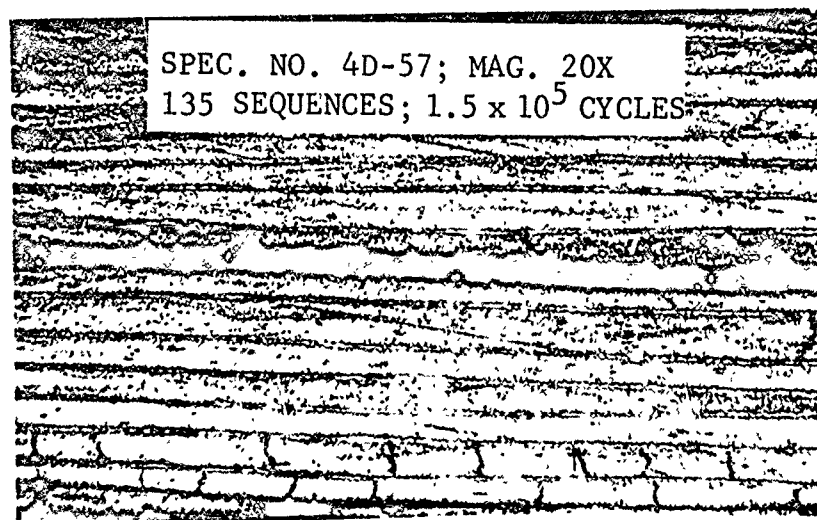
FIG. B-6 CROSS SECTIONAL PHOTOMICROGRAPHS OF MODMOR II/NARMCO 5206 PREPREG 16 PLY - 45° , 135° (WITH SCRIM CLOTH) COMPOSITE CANTILEVER BEAM SPECIMENS SUBJECTED TO VARIOUS FATIGUE ($R = 0.1$) LOAD SEQUENCES AT ROOM TEMPERATURE
